Response to CHRSA letter, “Response for Stop Work Order”

RE: CHSRA DID NOT DESIGN SAFE AND RELIABLE HIGH-SPEED RAIL CURVES NEAR THE SAN JOAQUIN RIVER. THIS IS A SECOND REQUEST FOR IMMEDIATE STOP WORK ORDER FOR MERCED TO FRESNO SECTION.

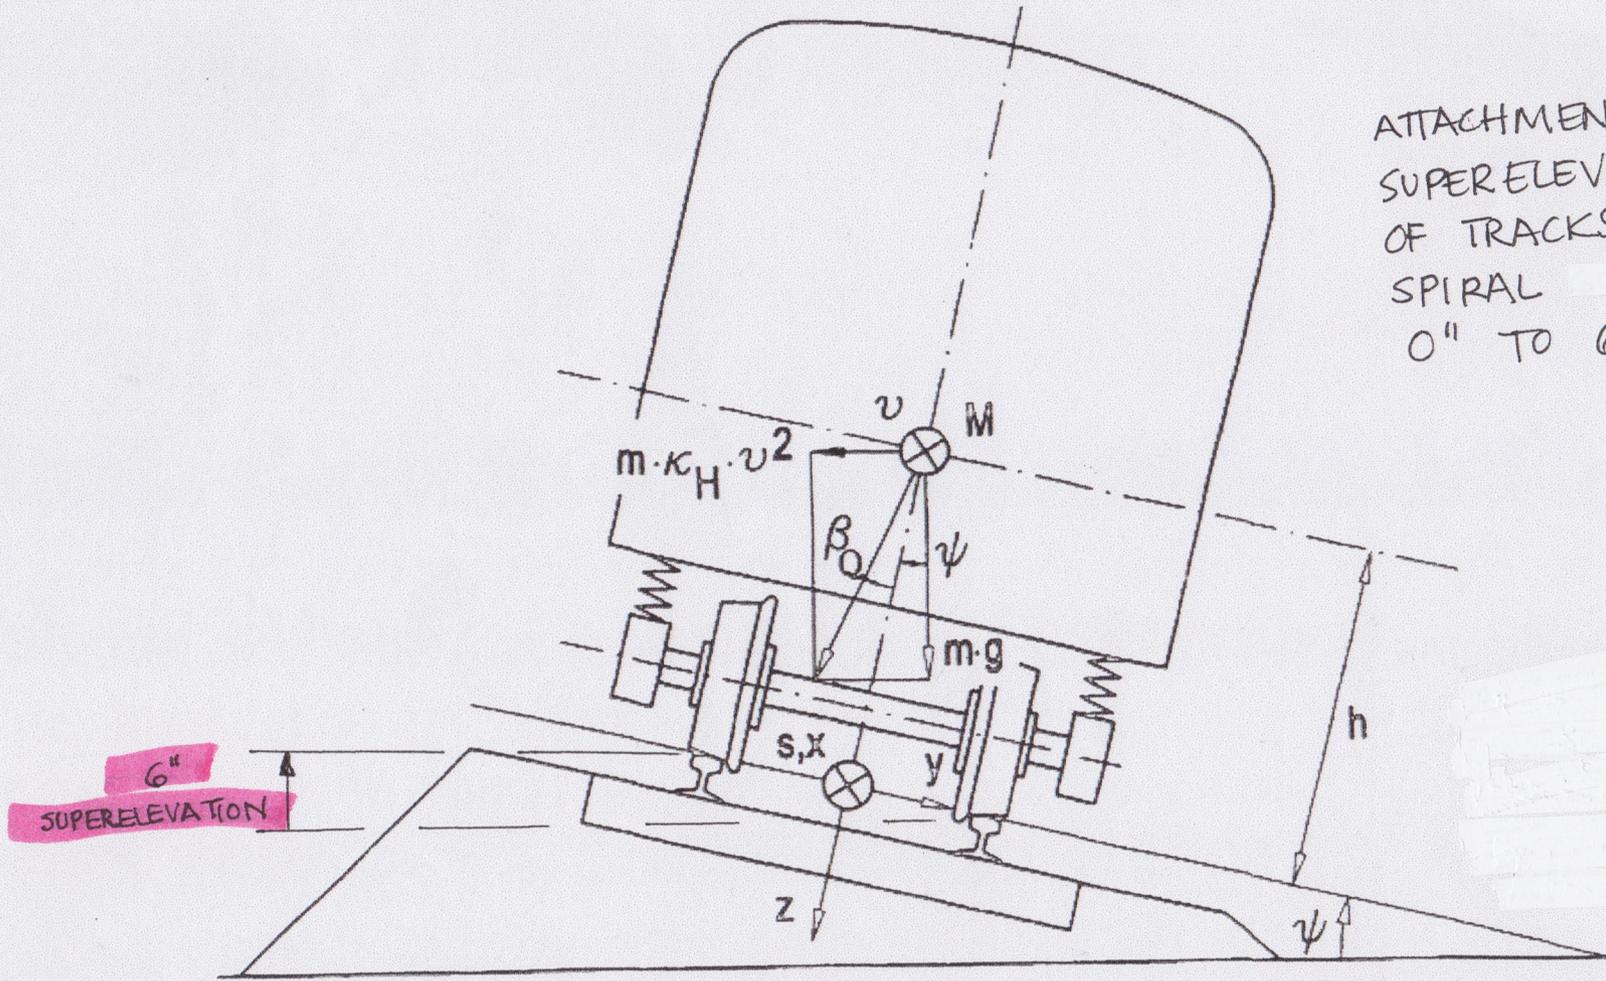
ATTACHMENT 1
 SUPERELEVATION
 OF TRACKS THRU
 SPIRAL FROM
 0" TO 6" MAX

LOOKING
SOUTHEAST

SCENARIO 1

In this case, the HSR train is traveling at a speed greater than a jetliner taking off from a runway. The train is going uphill and simultaneously, the left side of the vehicle is tilting higher on one side than the other to accommodate the centrifugal forces.

Then the vertical curve descends, goes downwards, and the left side of the train, the outside flange of the wheel, is still climbing the rail to accommodate for the centrifugal forces. When the rail begins its descent down the vertical curve, the left side of the train keeps rising off the top of the rail.
